Inspection Report - Special

Mine Name: Genwal

EVALUATION AND CONTROL OF COAL BUMPS

Office of Mine Safety and Health Research
National Institute for Occupational Safety and Health
Centers for Disease Control and Prevention
U.S. Department of Health and Human Services

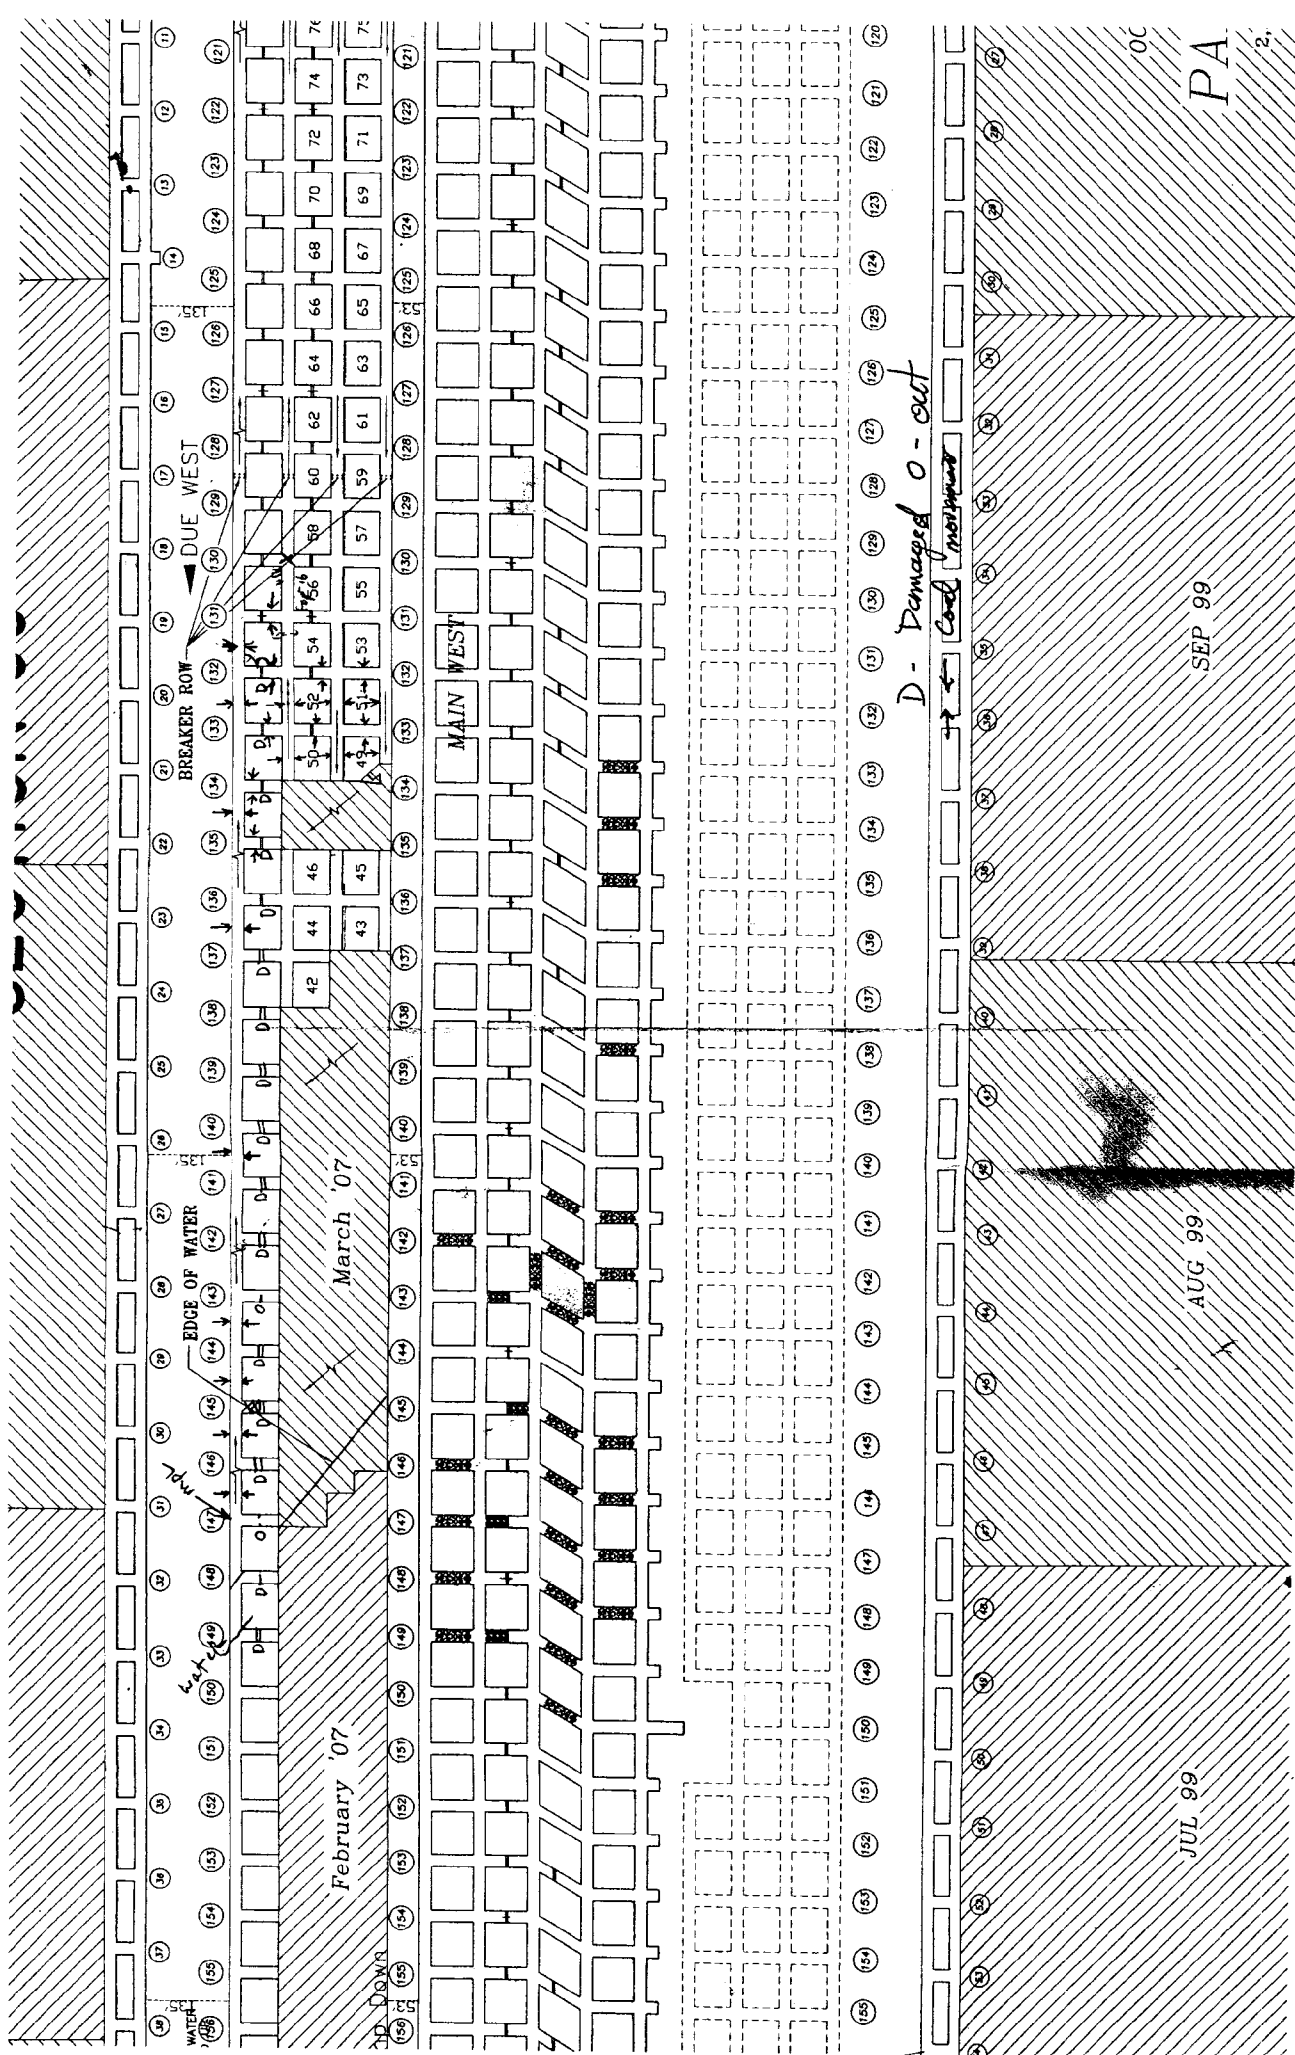
I arrived at the section and was able to get to between 133 and 132 crosscut where there was dangered off tape across the bottom 3 entries. A map of the aftermath with some of my notes written on the map is attached. It shows where pillar coal has spalled out into the entry and the condition of the stoppings along the north entry. I traveled down the north bleeder entry well inby the dangered off area and verified the items on the map. The situation at this section is clear. The section pulling the two bottom pillars on retreat out of this area was experiencing greater stresses on the pillars. This is coinciding with an increase of overburden from about 1400 feet depth back at crosscut 158 to now at crosscuts 137 - 133 where it is about 2000 feet deep. Pillar bumps were increasing and some damage to the stopping to the north bleeder entry were occurring. Genwal tried to stop the stress override and left two rows of pillars at 137 to 135 and then started up again with the south pillar at 134 - 135 crosscuts. Hurst reported that a few large bounces occurred on off shift soon after start up of pillar mining which did most of the damage. Entry ways outby two breaks from the face had extensive rib coal thrown into the entry way. Stress overrides out by the face were very concerning. The bounces had either knocked out or damaged all the stoppings to the north bleeder entry from crosscut 132 inby to crosscut 149. I could only travel the north entry to 143, but the observed conditions were severe. The weight of the area will only be the same or worse as this is under the ridge top on the surface. If Genwal was to try again, they must under law repair all damaged stopping along the north bleeder entry. They would also need to drop back out by the affected area at least 3 crosscuts and build seals that meet standards that are not yet established as a result of the Sego Mine explosion back east. Hurst said the risks are too great that this event will happen again out by should they try pillar pulling again and they can't justify all the extra expensive to repair and establish new seals. I gave them verbal approval to stop retreat mining for the rest of the section. Tom will send a modification to leave the rest of North Barrier and start on the south barrier. I gave them an ok to start on the south barrier as the boundary between UTU-68082 and the state lease runs down the barrier so that only the top or north most entry will be on federal. I asked how they would mine the south barrier and Tom said they are working on the MSHA roof control and ventilation plan amendment for the south barrier but was not sure if Genwal is asking to pull pillars after what they have seen in north barrier. The conditions noted in

North Barrier were adverse and as depicted on the mine map. Prudence dictates that any further mining of this area would result in more of the same and leaving the remaining coal is necessary. We will act on the written request when received for the official record.

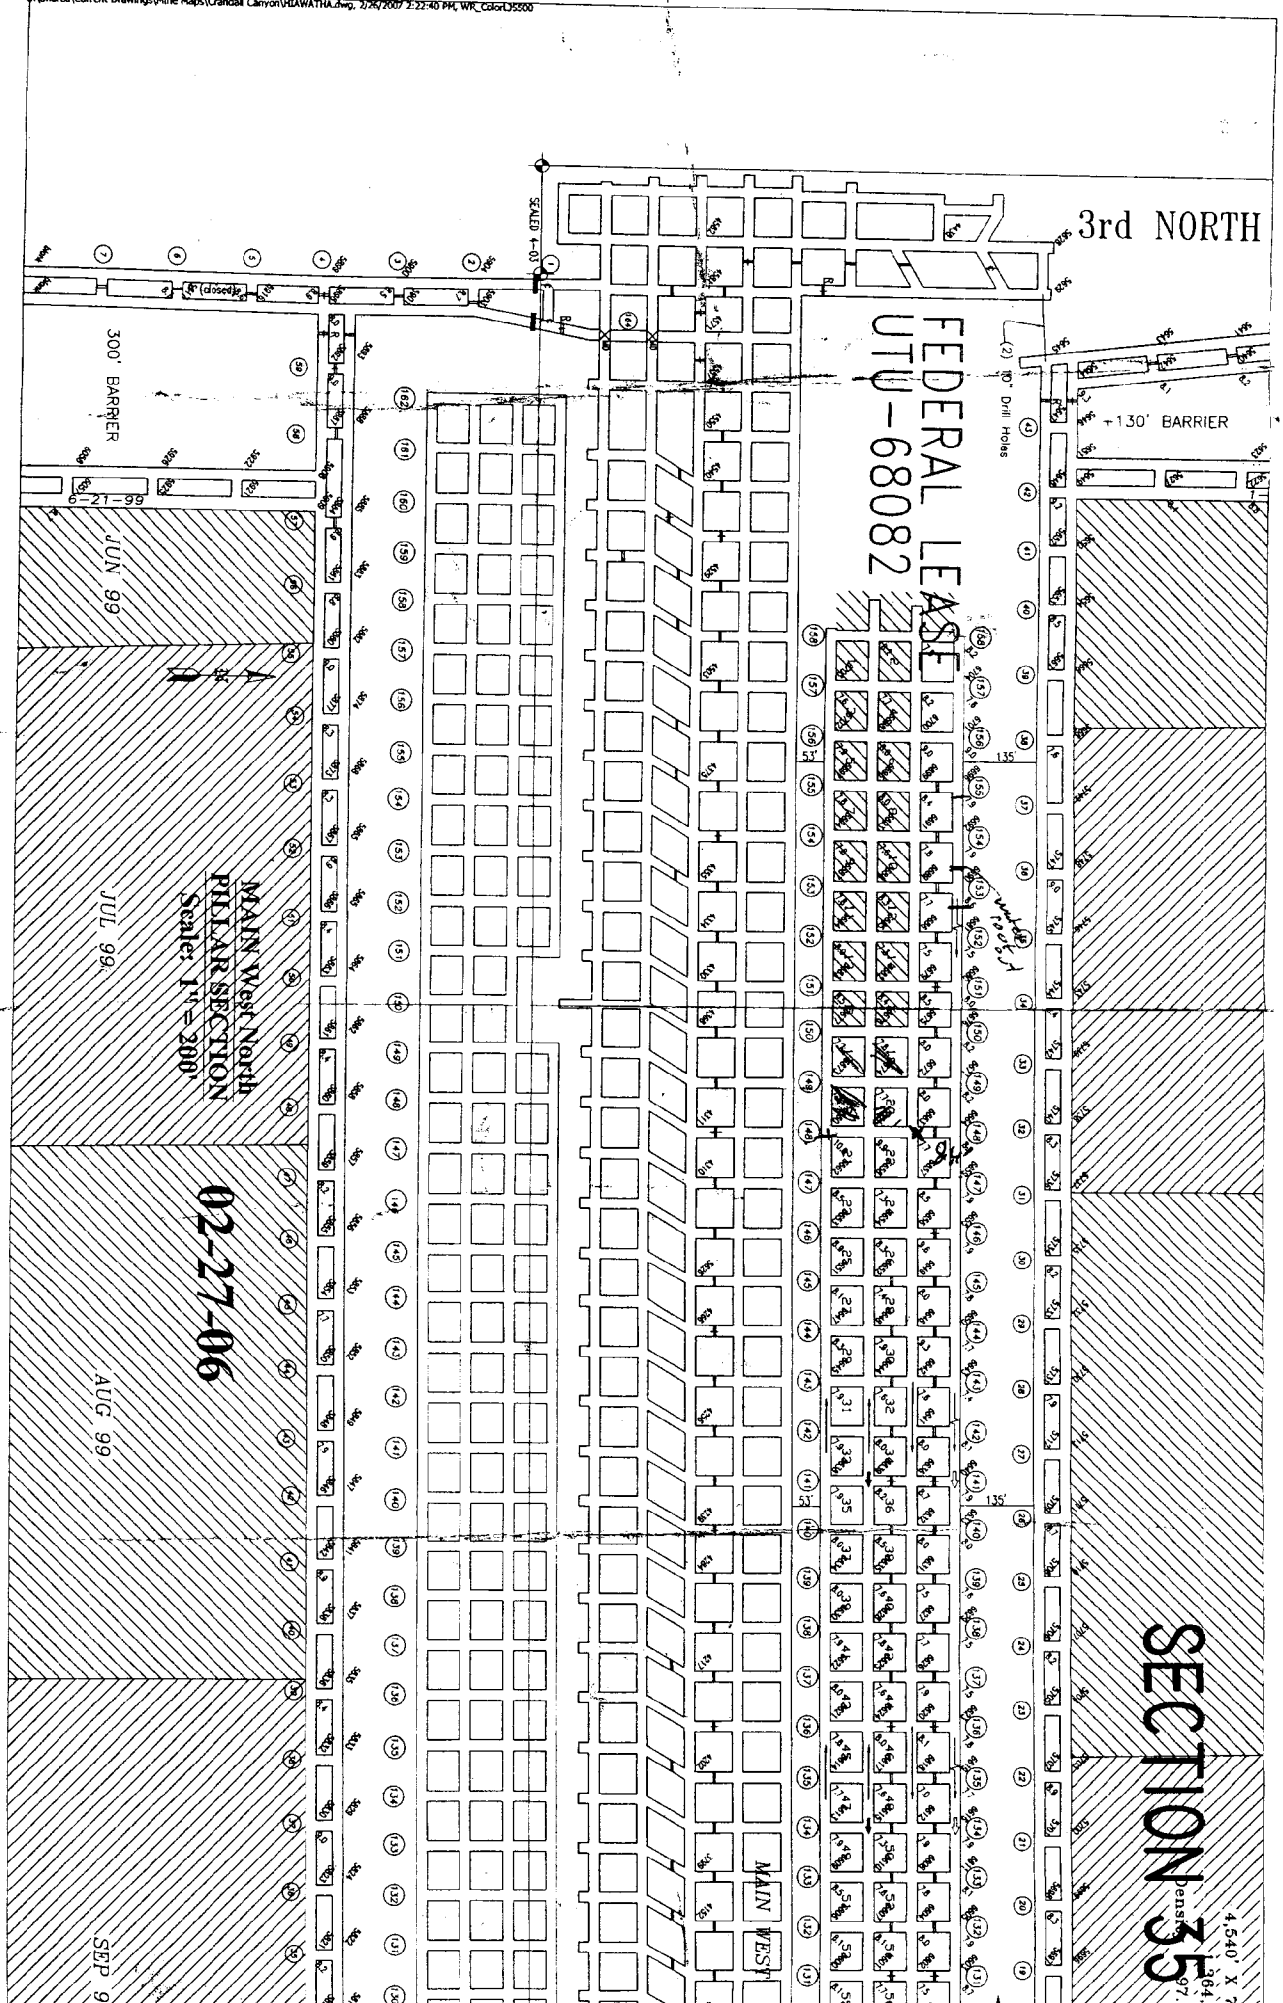
This section finished driving 4 entries on 92 foot entry centers and 80 foot crosscut centers. These were driven in the north barrier pillar between Main West and mined out longwall panel # 12. The barrier pillar is 450 foot wide which accommodates the 4 entries. This leaves only 130 foot barrier to the north longwall panel. This section started out back at Main West crosscuts 108 - 110 and drove out to crosscut 158. Here the section starts to dip down to the west before the Joe's Valley Fault. At this place, the section experienced large inflows of water. They could not control it enough with pumps. We think this is water flowing through fractures close to the fault, draining the gob to the north. Crosscut 158 is about 400 feet short of the bleeder entries along the fault. With the water coming in too fast, the company stopped advance at this point and began pulling pillars back. They got a special pillar plan approved by MSHA to pull the south two of three pillars and have the return out the north most entry. So far, the crews have pulled 18 pillars or 9 rows. Currently they are pulling the pillars between crosscut 149 and 150. I have been concerned about pulling pillars in this environment with mining a narrow block with little coal barriers to mined out blocks on both sides. Fortunately, the beginning depth on the west end toward the Joe's Valley Fault is somewhat shallow starting at 1300 feet. So far no inordinate pillar stresses have been noted, though thing should get interesting soon. The face is under 1600 feet of cover now and will increase to over 2000 feet by crosscut 139. The working face looks ok and coal is good. There is some cap rock in the roof that is not holding up during mining. Coal height is running about 9 feet. The rate of retreat mining is well ahead of water build up as the seam has a incline down to the west fault starting with pillar row 144, so the water is running down to the end of the entries. Measurements are noted on the attached map.

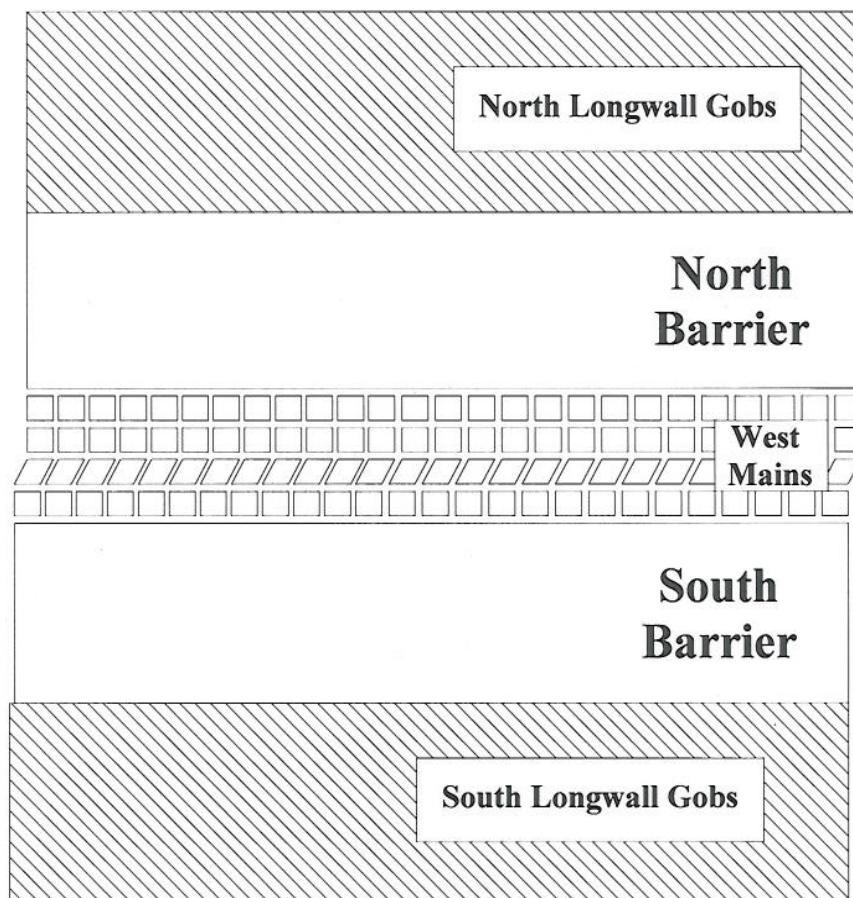
Figure 6. West Mains development as modeled in the NIOSH ARMPS analysis.

Figure 6 shows the initial situation before any mining in the North Barrier. The 70 by 70 ft pillars in the mains have an SF of 0.93, which the NIOSH guidelines suggest should be adequate

for the 2,000 ft maximum sustained depth of cover. The pillars are shielded from the extensive longwall gobs to the north and south by 450 ft barrier pillars whose BPSFs are approximately 4.4.

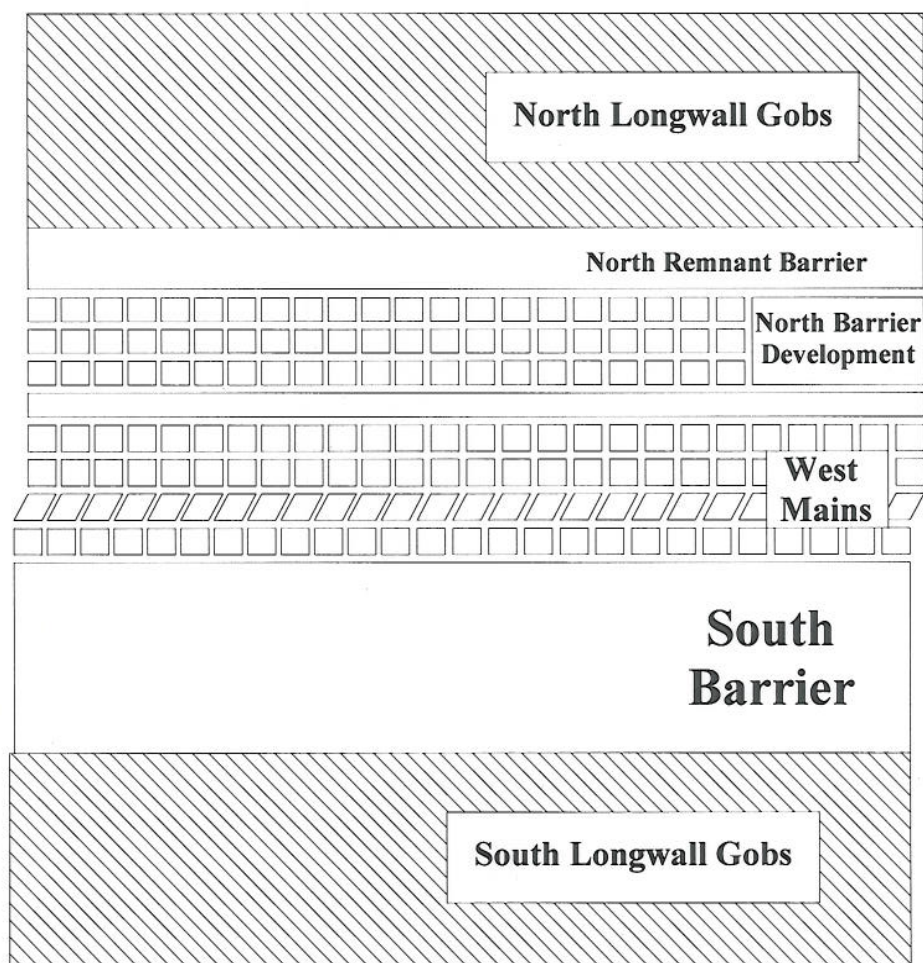
Figure 7. North Barrier development as modeled in the NIOSH ARMPS analysis.

In figure 7, development has been completed in the North Barrier. The analysis assumes that the pillars in the mains are carrying their full load and are not transferring any to the pillars in the North Barrier development. However, significant abutment load from the north longwall gobs is being transferred across the Remnant North Barrier, resulting in an ARMPS SF 0.46 for the 63 by 73 ft pillars. Most important, the BPSF for the 130 ft wide remnant barrier pillar is just 0.95.

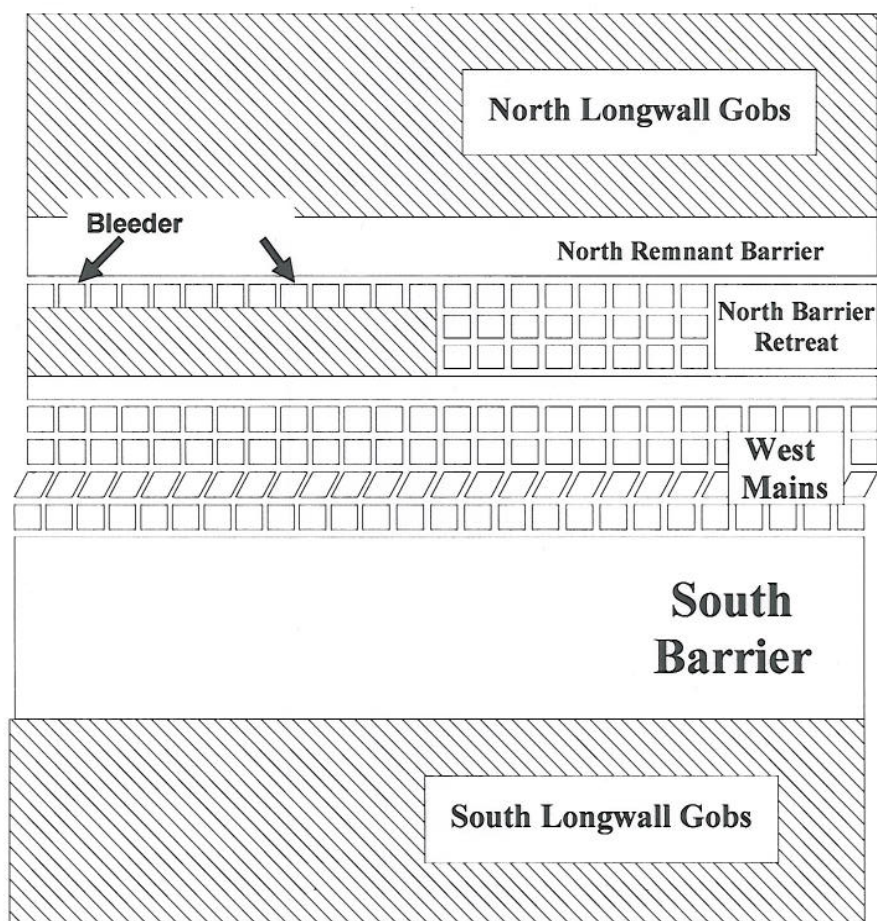
Figure 8. North Barrier retreat mining as modeled in the NIOSH ARMPS analysis. (the model assumes that the row of bleeder pillars has yielded and shed its load).

Retreat mining in the North Barrier does not affect the BPSF, but it further reduces the SF of the pillars to 0.32.³ This was the situation when the bump occurred in early March of 2006 that resulted in the abandonment of the North Barrier pillars (figure 8).

³ The NIOSH analysis presented in the text treats the row of bleeder pillar as if it was extracted with the other two pillar rows. An alternative analysis, using an “effective barrier pillar width” of 160 ft with two rows of extracted pillars, has little effect on the pillar SF but increases the BPSF to 1.17.

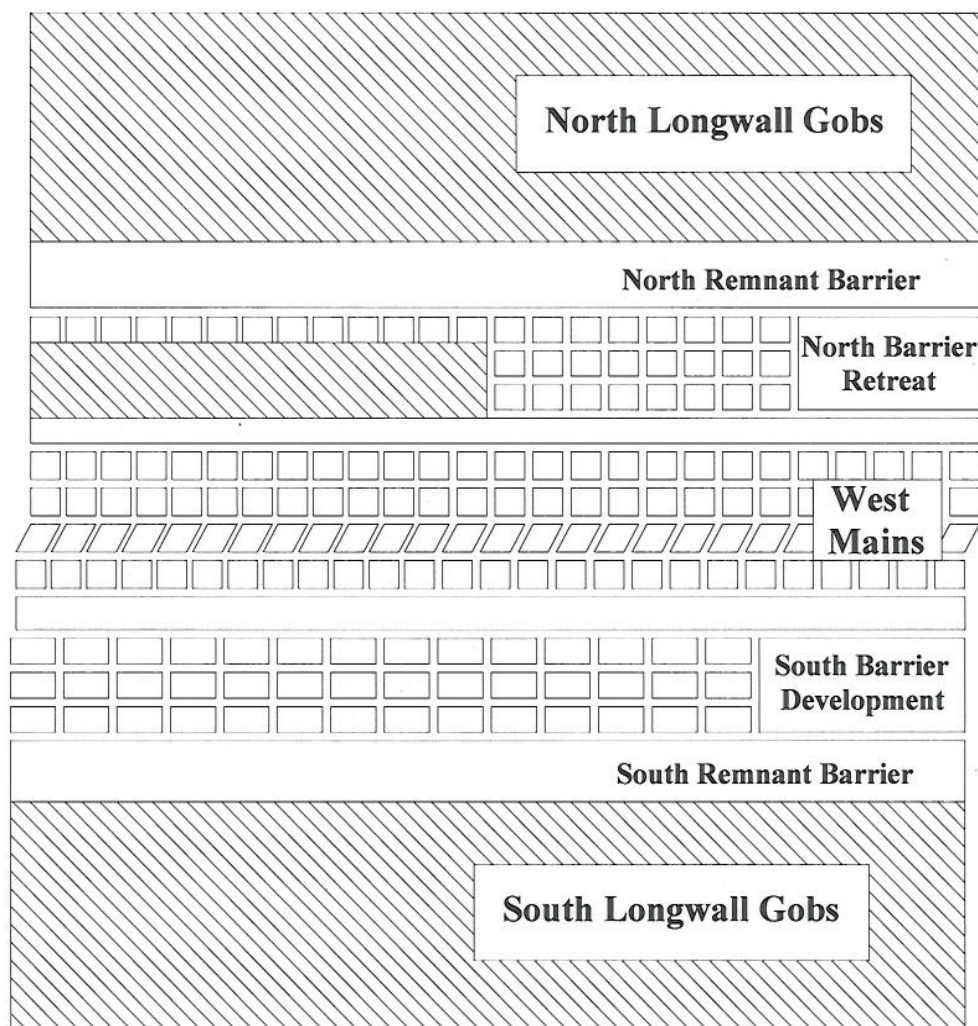
Figure 9. South Barrier development as modeled in the NIOSH ARMPS analysis.

The development in the South Barrier created pillars that were about 50 ft longer than the ones that had been used in the North Barrier (figure 9). The change increases the pillar SF by only about 15%, to 0.52, because the strength of a coal pillar is largely determined by its least dimension. The remnant south barrier pillar is 10 ft narrower than the one in the north, however, so its BPSF is estimated at 0.91. Pillar recovery, which in the South Barrier involved a slab cut into the remnant barrier, would have further reduced both the pillar SF and the BPSF. Pillar recovery never progressed into the deepest cover portion of the panel, however.

One other consideration in evaluating the South Barrier is the potential for load transfer resulting from failure of pillars in the original West Mains. Once the pillars in the North Barrier have been extracted or failed, an abutment load can be transferred across the slim 50 ft pillar that separates the North Barrier Development from the West Mains. Under these circumstances, the SF for the mains pillars is reduced to 0.71, while the BPSF for the 50 ft barrier is just 0.74. Failure of the pillars in the mains could ensue, and it would result in a second side abutment being applied to the pillars in the South Barrier, further reducing the pillar SF there to 0.35.

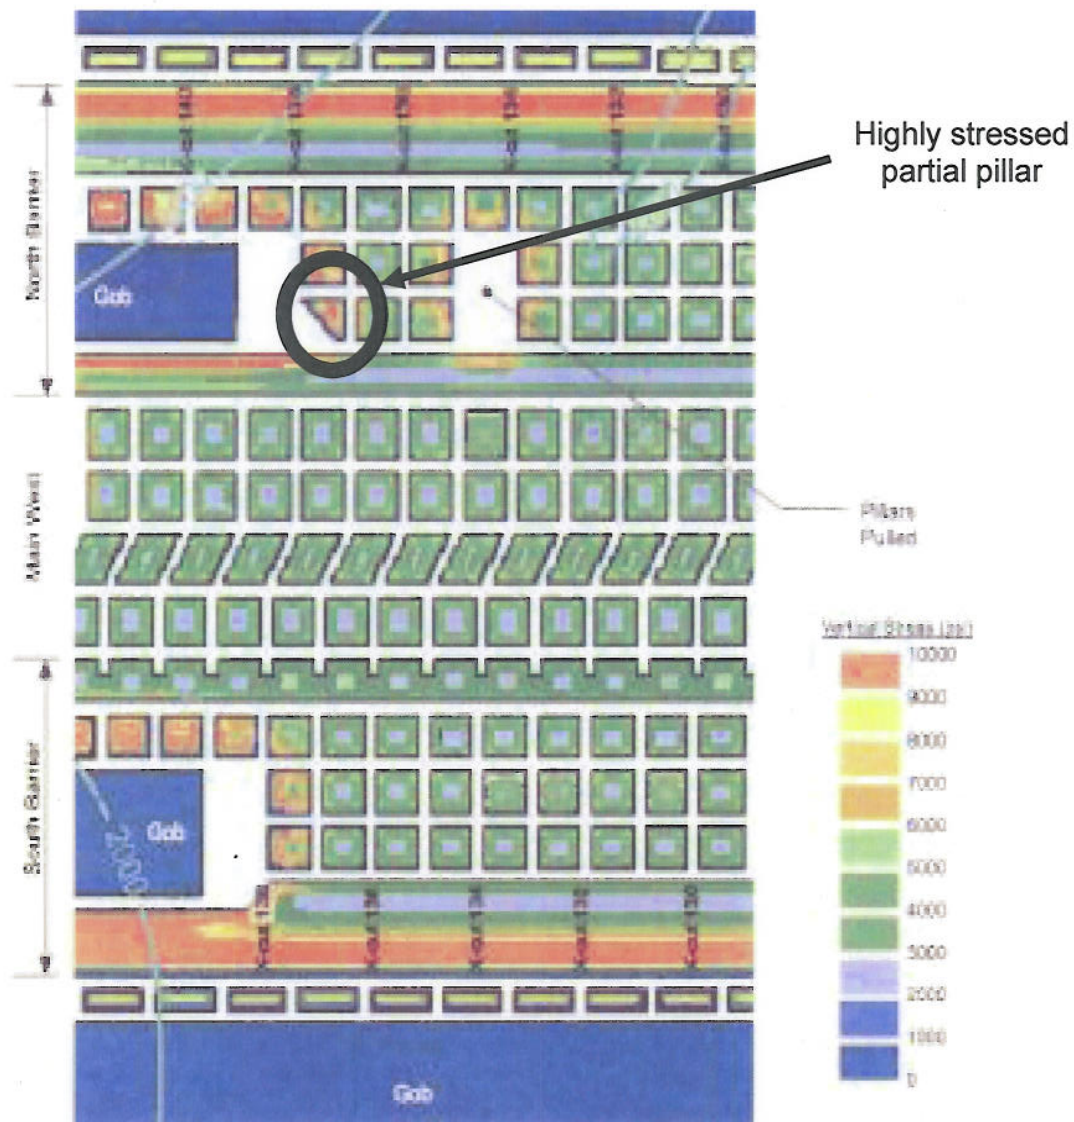
AAI used elastic elements when modeling the remnant barrier pillars, according to information available to NIOSH. Elastic elements do not yield at any load, and the model results show unrealistically high stresses in excess of 30,000 psi developing near the edges of the remnant barrier pillars (figure 10, July 20 2006 AAI report).

The high strength of the coal elements employed in the AAI models means that very little load transfer takes place within the models. The same figure 10 cited above shows that the abutment load from the longwall gobs is almost entirely dissipated within 100 ft of the gob edge, leading AAI to conclude that "stress conditions are expected to be controlled by the depth of cover and not by the abutment loads." Within the panels, the AAI models indicate that even yielded pillars carry very high loads. For example, on page 6 of the April 18, 2007 report, a half-extracted pillar within the North Barrier is shown as almost entirely "yielded." Yet the figure on page 5 (reproduced here as figure 10) seems to show that the same remnant is carrying stresses approaching 10,000 psi!

Figure 10. LaModel result shown on page 5 of the AAI report dated April 18, 2007, showing a very highly stressed, partially extracted pillar.

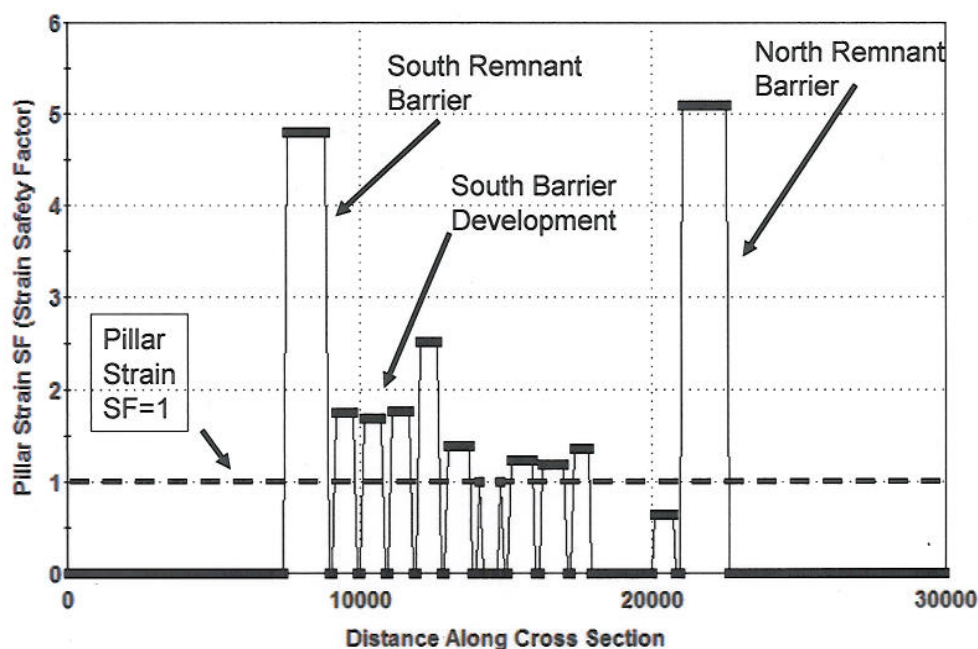
NIOSH has prepared a LaModel grid based on the geometry shown in figure 9. Models have been run to illustrate the effect of changing the coal strength on the results. LaModel provides cross-section plots of the “pillar strain SF,” which is a measure of pillar stability but is not directly comparable to the ARMPS SF. Figure 11 shows that when 1,640 psi is used for the in situ coal strength, none of the pillars in the South Barrier have yielded, and in fact they seem to be maintaining pillar strain SFs that are above 1.5. Reducing the in situ coal strength to 1,250 psi reduces the pillar strain SFs to approximately 1.0, which might be considered marginally stable. When the default value of 900 psi is used, all the pillars in the West Mains fail, and a portion of their load is transferred to the South Barrier development pillars. The calculated pillar strain SFs for the pillars in the South Barrier are all below 0.5, and are indicative of significant distress. Clearly the value selected for the in situ coal strength has a very large effect on the model results.

Figure 11. LaModel results with an in situ coal strength of 1,640 psi. Only one pillar has a LaModel pillar strain SF less than 1.0.

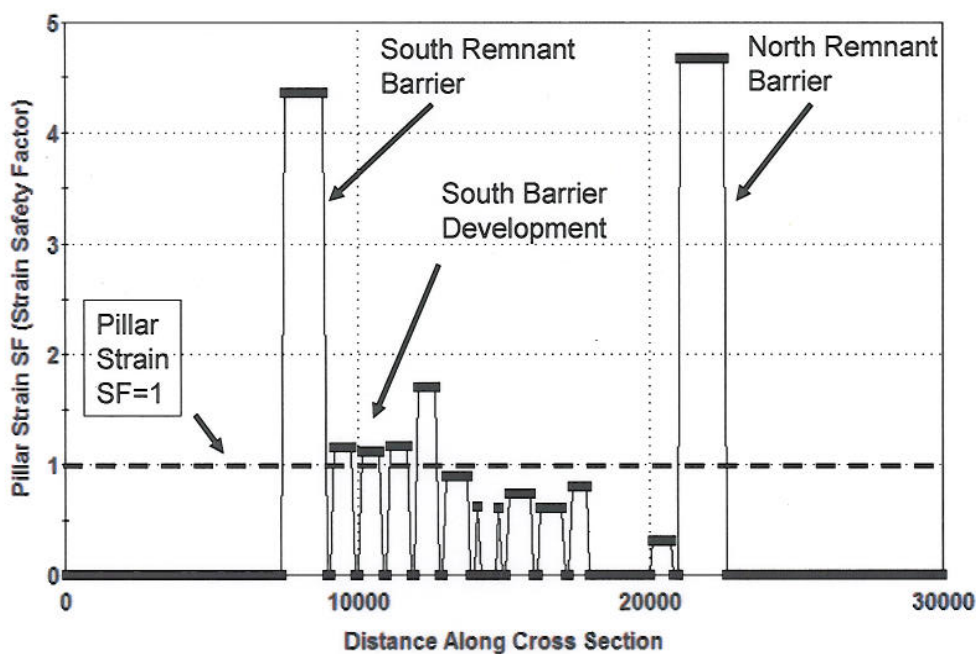
Figure 12. LaModel results with an in situ coal strength of 1,250 psi. Most pillars have LaModel pillar strain SFs of approximately 1.0.

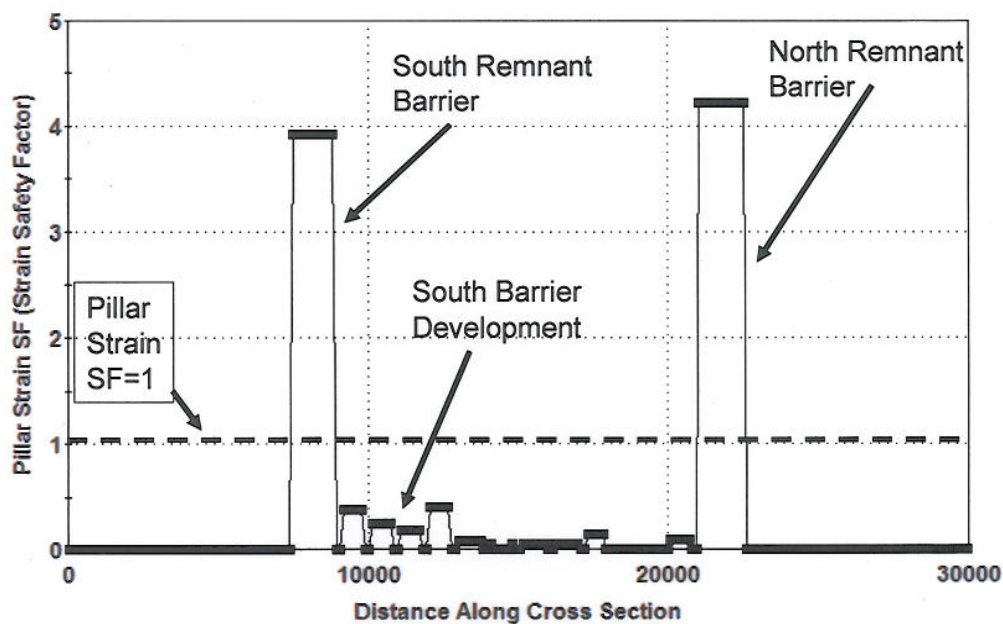
Figure 13. LaModel results using the default in situ coal strength of 900 psi. Most pillars have LaModel pillar strain SFs that are well below 1.0.
